Case Study: Lake Forest Reservoir Relining & Floating Cover

THIS PAPER WAS ORIGINALLY PRESENTED AT THE 2023 GEOSYNTHETICS CONFERENCE | KANSAS CITY, MO, USA

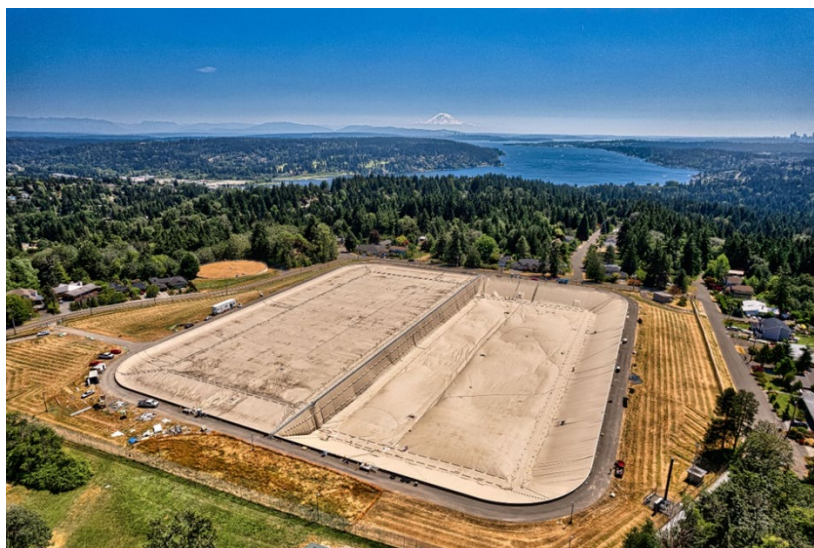
Figure 1. Aerial view of the completed east cell (left side) completed in 2021 and west cell (right side) reservoir under construction in July 2022

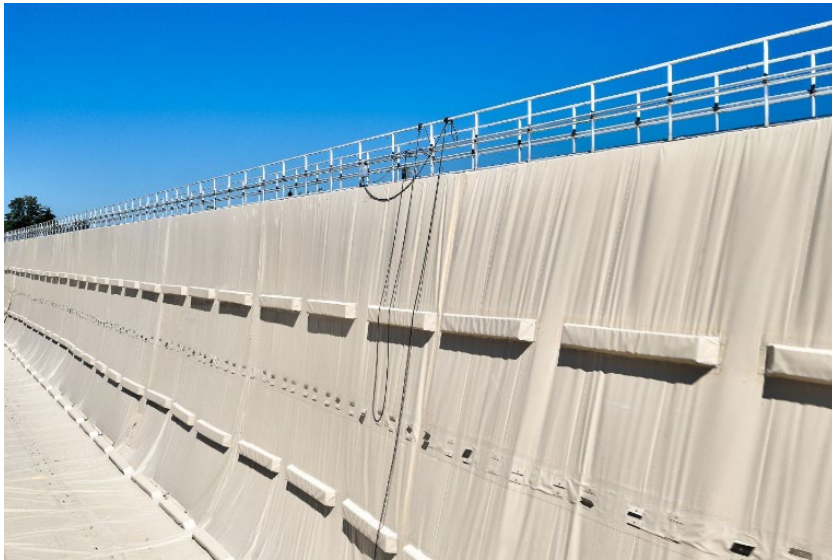
Figure 2. Installation underway of double trough system on 28-foot divider wall on west cell

operating levels, a special double trough system was designed and installed. The installation of this required large custom size panels be fabricated in the factory. These panels then needed to be lifted onto the vertical wall on site to be vertically welded together. The joining of the panels required 3-inch (7.62 cm) wide field seams. The perimeter parapet wall required each panel to be lifted above the parapet wall for deployment of the factory produced panels and anchorage to the top of the perimeter wall. The geomembrane liner was anchored at the base of the perimeter wall and the floating cover was anchored to the top of the perimeter wall. The mechanical attachment consisted of stainless steel concrete anchors and stainless steel batten bars with rubber gasket material. The welding on site was done primarily by thermal wedge and performed in compliance with the Geosynthetics Research Institute GM 19 standards and engineers specified field factory and seam strength requirements.

The weight tensioned floating cover system in both reservoir cells also required various additional appurtenances including access hatches, air vents, access stairways, double material over existing concrete stairs on slope, and a pump surface water removal system. Figure 2 below shows the installation of the divider wall trough system on the west cell. Figure 3 shows the east cell wall trough system in application at close to full operating level of the reservoir.

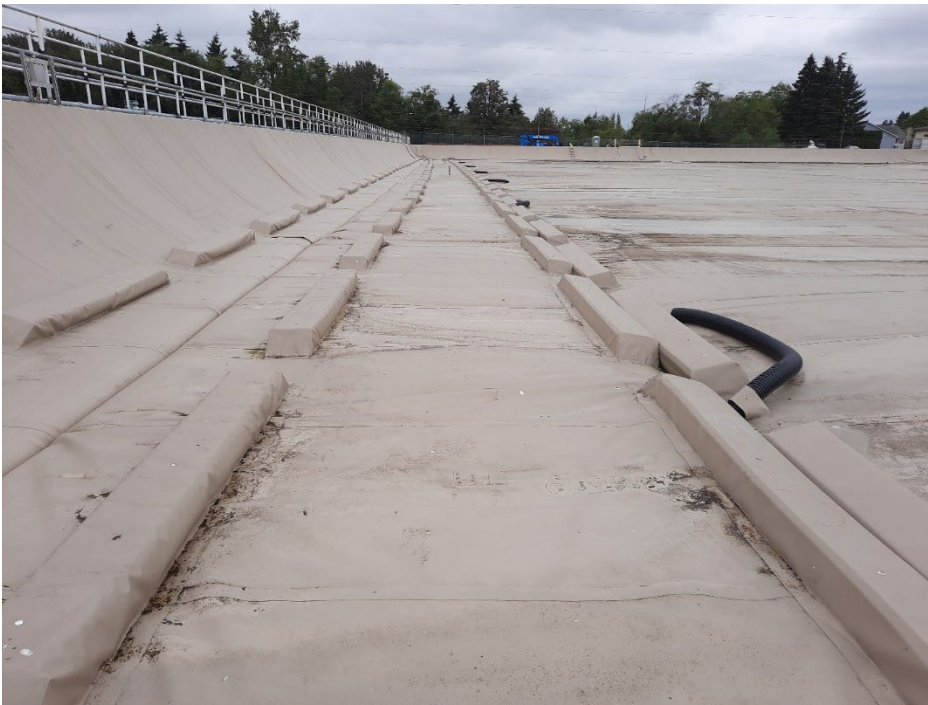
Figure 3. East cell divider wall trough in full service

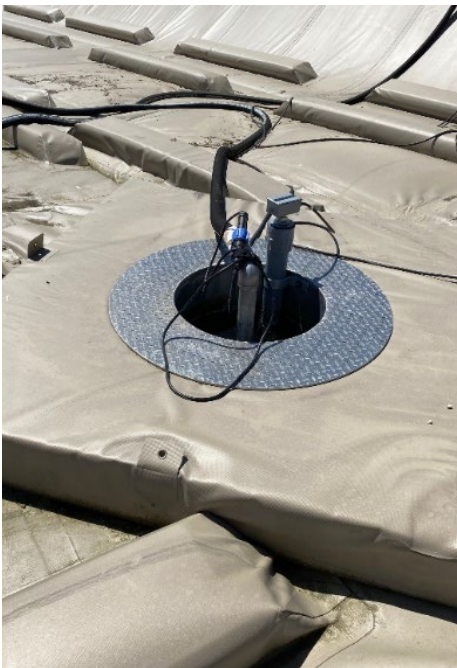
Figure 4. Rainwater Removal System

The rainwater removal system was designed for a 10-year, 24-hour duration and 25-year, 24-hour duration storm event. The number and size of the rainwater removal system pumps was based on a 48-hour and 72-hour removal capacity. Each cell has five submersible sump pumps housed in perforated aluminum sump cans located in the rainwater collection troughs. The surface water is pumped to the top of reservoir perimeter and discharge into pipes located outboard of the perimeter parapet wall. Figure 4 shows one of the aluminum sump cans located in the east reservoir cell. Figures 5 – 10 show additional installation and inflating testing performed during phase 2 on the west cell.

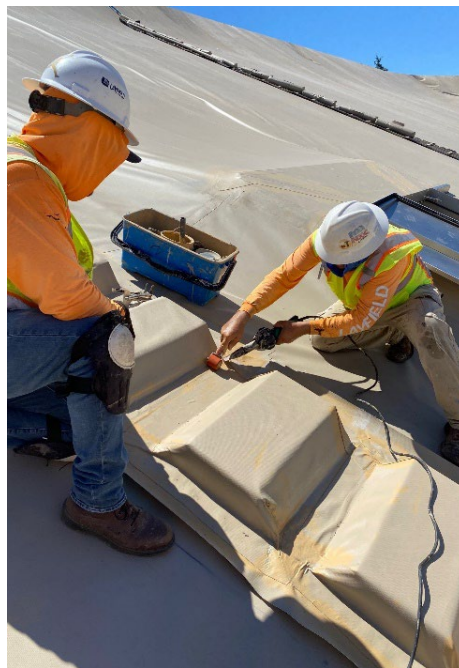
Figure 5 and 6. Crews installing fabricated entry stairways and welding floating cover seams

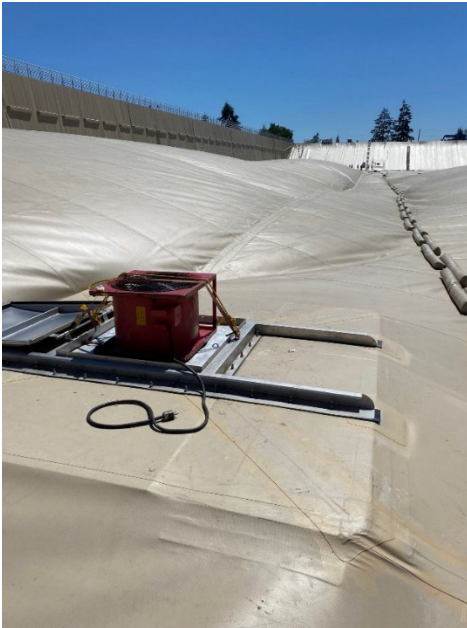
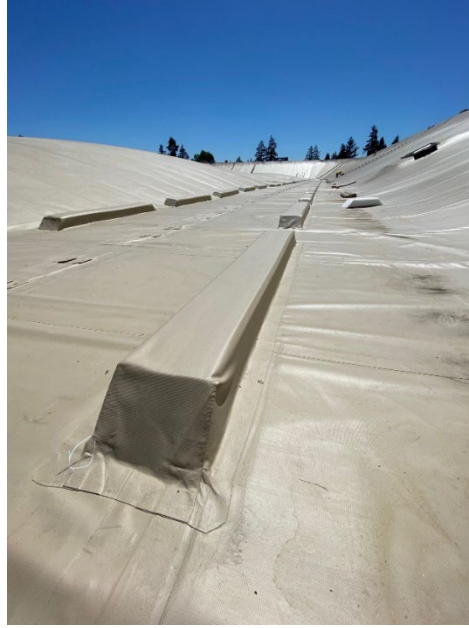
Figure 7 and 8. Inflation via access hatch and west cell cover undergoing inflation inspections.

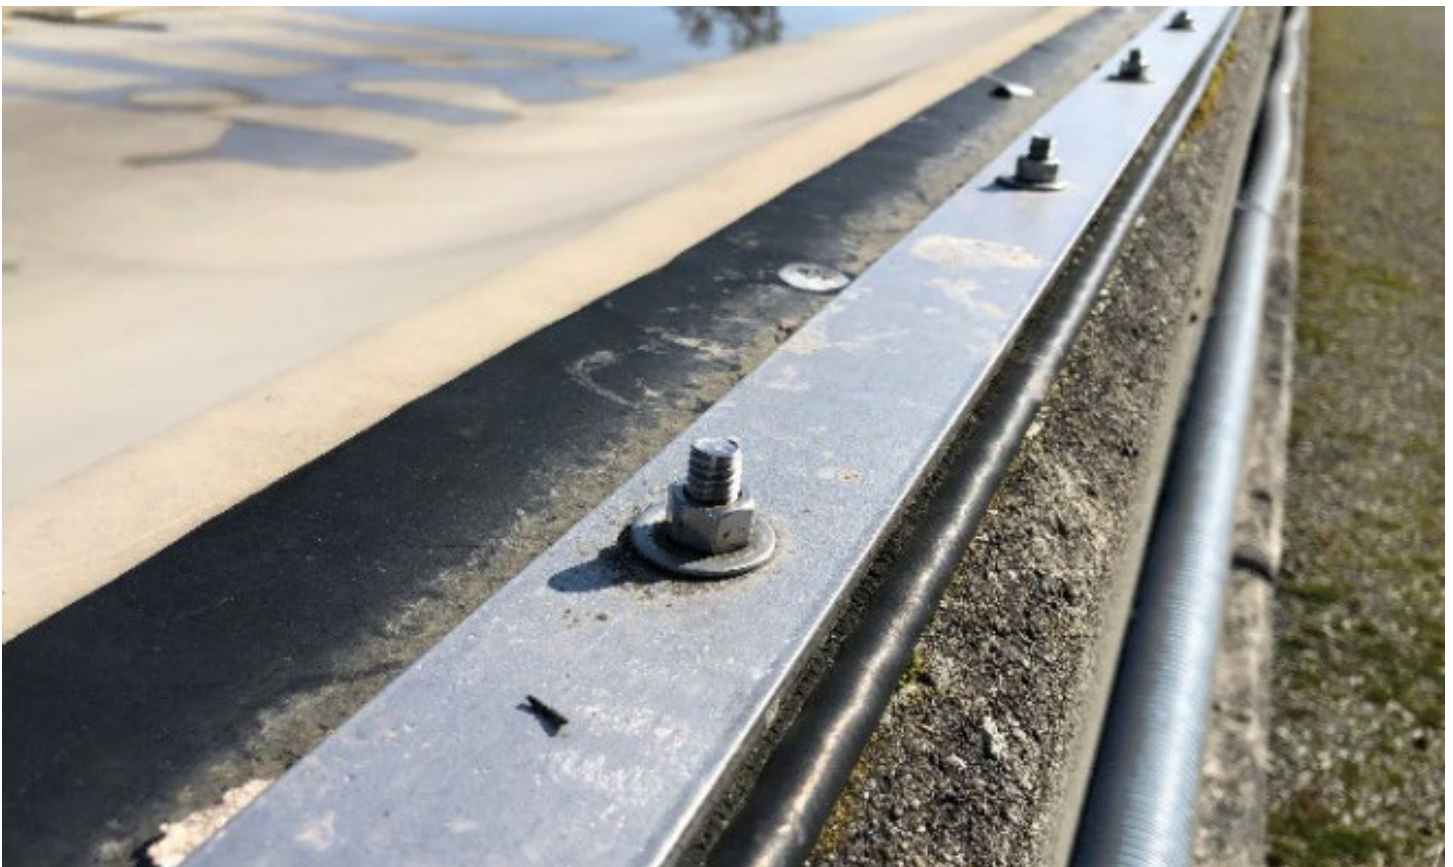
Figure 10. Floating cover mechanical anchorage at parapet wall

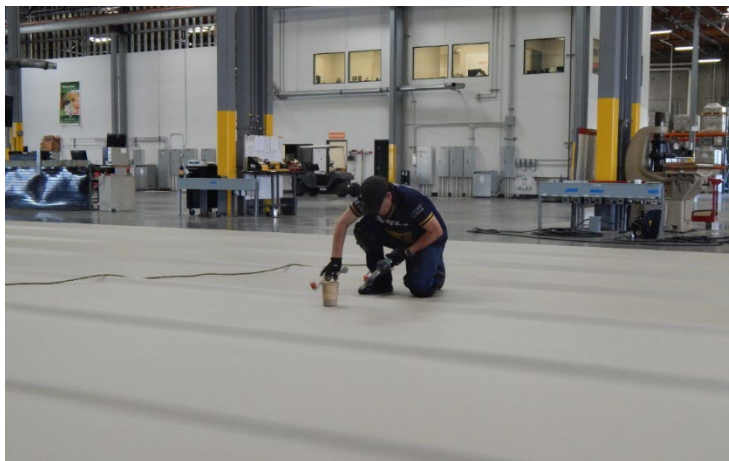
Figure 11. Factory fabrication of CSPE panels in our Lakeside, CA Plant

The Lake Forest reservoir required substantial prefabrication of the geomembrane liner, floating cover, and appurtenances. The project required approximately 850,000 ft² (79,000 m²) of prefabricated geomembrane panels. This included a large amount of custom size fabricated panels to address the divider wall and various curves and slopes of the reservoir. In total the project required close to 120 days of equivalent plant fabrication time. The prefabrication of the geomembrane liner, cover and components resulted in substantial reduction in the amount of required field welding, construction time and installation cost. This was also important considering the highly inclement weather conditions typically experienced in the Seattle and Puget Sound region of Western Washington.

There are many recognized performance advantages of using factory fabricated panels for geomembrane liners and floating covers. The constant and favorable factory-controlled environmental conditions yield higher quality, better seams between individual geomembrane rolls, than field fabricated geomembranes and fewer opportunities for damage by field activities and personnel. The Fabricated Geomembrane Industries (Stark et al. (2020) has previously compared factory and field welded thermal geomembrane seams for a large off-stream water reservoir project. This comparison showed that factory welded seams exhibit higher seam peel and shear strengths, less variability, and more consistency than field welded thermal seams. The compiled test results showed that factory seams are about 10% stronger than field seams. Factory fabrication can typically result in about 75% less field seams on a project.

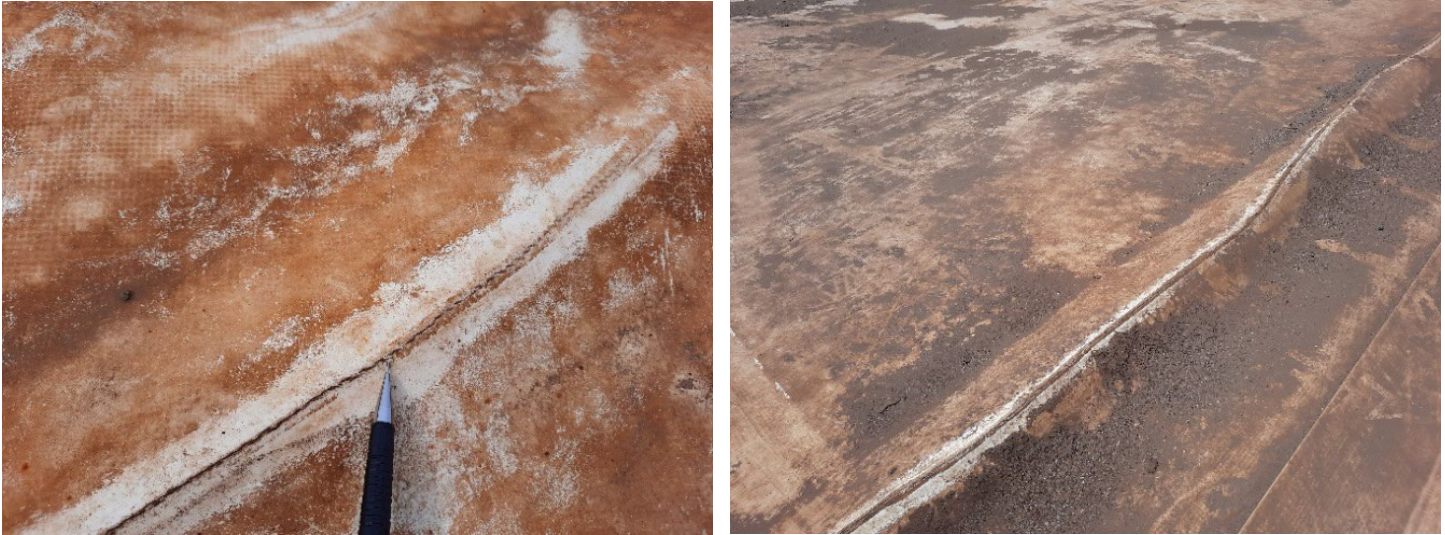
Figure 12 & 13. Surface cracks found in the RPP liner material folds and creases.

The material selection process was an important factor for the geomembrane liner and floating cover portion of the project. The current reinforced polypropylene (RPP) material had demonstrated signs of fatigue and premature degradation at approximately 16 years in service. This included various cracks located around folds and creases as per Figures 12 and 13 below. Also, the extent of damage on the geomembrane liner material could not be determined until the reservoir was taken out of service and the floating cover system was fully removed. The type of cracking in the material folds is often associated with multiple factors including prolonged UV exposure, continuous exposure to chlorine used for potable water disinfection, and stress concentrations at upstanding folds resulting from hydrostatic pressure. Chemicals used for disinfectants in municipal water treatment include chlorine and chloramines and can function as accelerators in breaking down or leaching out the protective antioxidant packages of certain geomembranes resulting in environmental stress cracking and premature material failure (Mills 2011).
