Upper Chiquita Reservoir Floating Cover and Liner

Andrew Mills, Layfield Geosynthetics, USA

THIS PAPER WAS ORIGINALLY PRESENTED AT THE 2013 GEOSYNTHETICS CONFERENCE | LONG BEACH, CA, USA

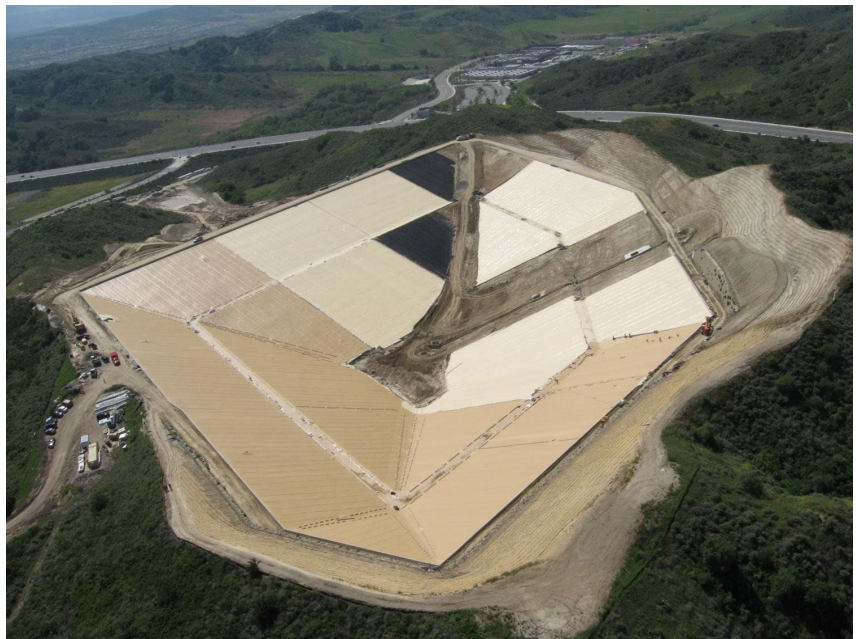
Figure 1. Aerial view of the Upper Chiquita Reservoir under construction.

The Upper Chiquita Reservoir is one of the first large emergency potable water reservoirs to be built in Orange County in decades. It has a design capacity of 244 million gallons (750 acre-feet) and has a surface area of approximately 18 acres. The reservoir is of new construction being built into the side slopes of the Chiquita Canyon. The reservoir was formed by constructing an earthen dam across the mouth of a section of the canyon to create a roughly triangular containment. At its deepest point it is 120 feet deep with side slopes ranging from 3 to 1 up to about 2 to 1. The construction of the reservoir began in June of 2009 and was put into service in October of 2011.

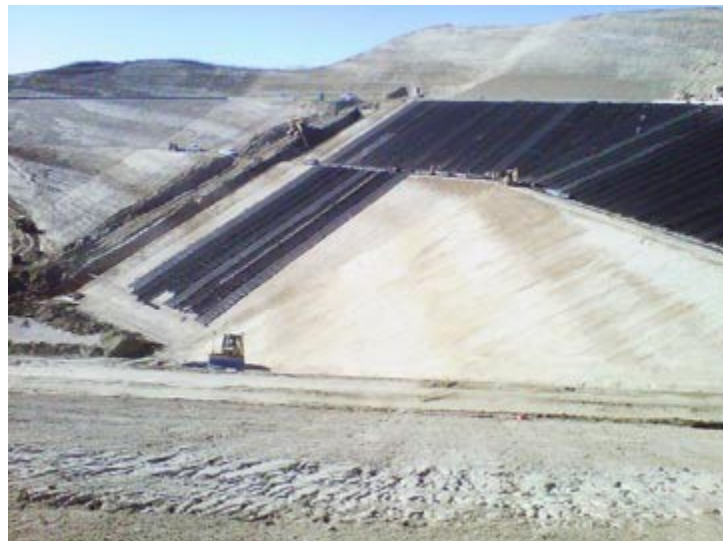
Figure 3. Placement of the geocomposite underdrain.

A geosynthetic underdrain was placed as the first layer of material underneath the entire reservoir. This underdrain was placed to monitor the performance of the lining system and to provide drainage during construction. The underdrain also provided drainage

for the earthen dam section. The underdrain consisted of a tri-planar double-sided geocomposite. The core of the geocomposite was 300 mil (7.6mm) thick and was sandwiched between two layers of 8 oz/yd² (270 g/m²) non-woven polypropylene geotextile.

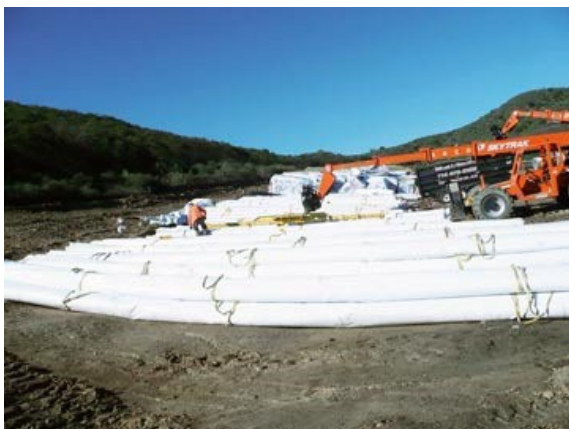
Figure 4. 36' Wide prefabricated liner panels

The fRPP materials for the liner were prefabricated prior to installation according to a detailed panel layout. All seams were welded using a 3" wide wedge welder that bonded the materials together edge to edge without leaving a flap of material at the seams. In order to reduce creases in the lining material the fabricator on this project used a 36' wide winder to create rolls of fabricated materials that did not require any folds in the material. There is some thought that creases in fRPP materials can lead to stress concentrations that can initiate failures. This is especially problematic in thicker materials such as a 60 mil material. By fabricating without folds this particular fabricator was eliminating this area of potential problems.

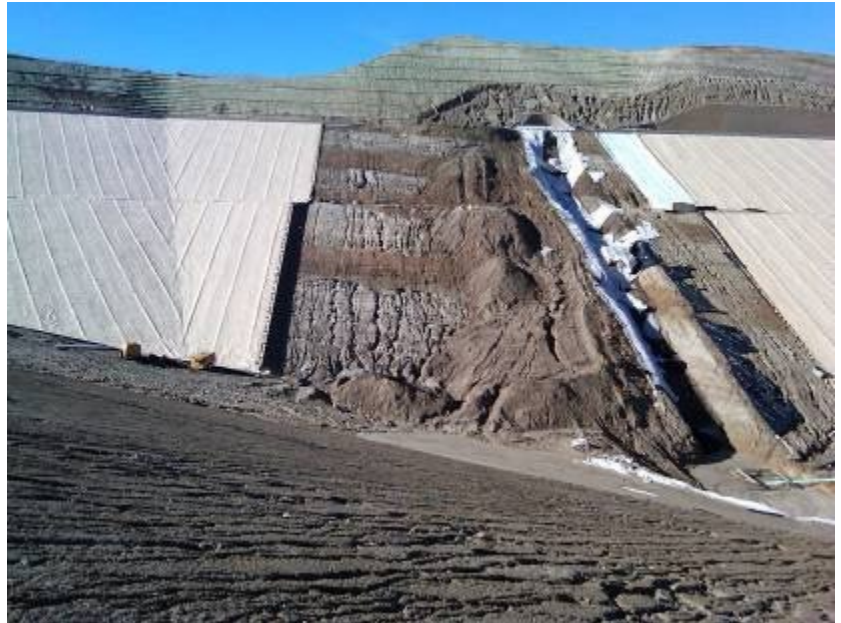
Figure 6. Subgrade damage after a significant rainfall event.

The construction of the reservoir started in the summer of 2009 and progressed well until the winter of that year. The winter of 2009/2010 was very rainy and there were many project delays. The large volumes of water kept the base of the reservoir very wet so that the earthworks could not be completed and the lining could not cover the base of the reservoir. The winter of 2010/2011 was even wetter with one particular week seeing over 10 inches of rain. "The rain gauges overflowed three days in a row" said Bart Lantz, project manager for SMWD. This rain event washed out a portion of the subgrade underneath the liner and a large section of liner had to be removed and the subgrade repaired. Over 200,000ft² of liner was pulled back to access this repair area. It took more than a month for the earthworks contractor to dry out the site after this rain event.

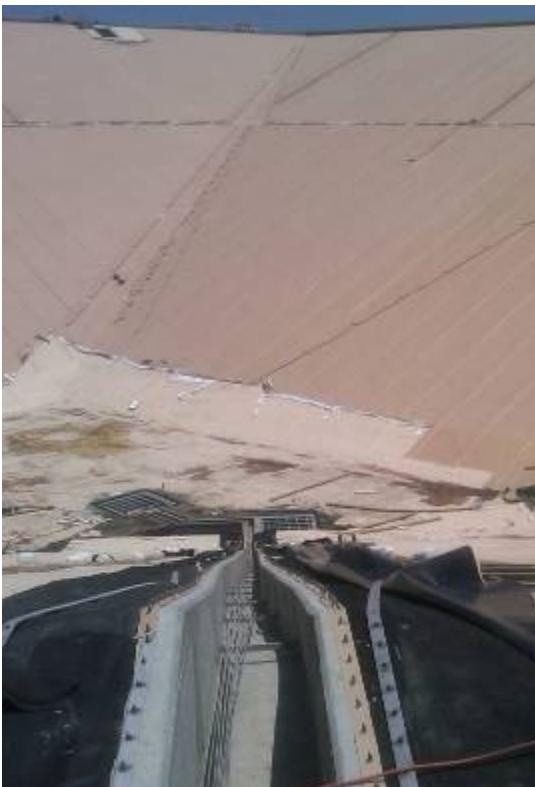
Figure 7. Pneumatic tubing in concrete trough

The first steps were to send divers into the reservoir to see if they could spot any obvious leakage. Immediately they detected leakage in the concrete trough area that carried the pneumatic lines to the base of the pond. Using underwater epoxy the divers attempted to stop the leaks however there appeared to be too many leaks to stop effectively with this technique.

The reservoir was drained and the cover and the liner were cut back to expose the concrete trough. The trough was completely filled with additional concrete and then matched to the surrounding the subgrade. The geocomposite and liner materials were then extended over this sealed trench. The operators of the facility were concerned about the maintenance implications of sealing the pneumatic lines in concrete so a secondary set of pneumatic lines were placed on top of the liner in case they are needed in the future. The facility will operate with the encapsulated pneumatic lines until they malfunction and then a diver can switch the lines over to the newer lines on top of the liner using valves in the reservoir. Once the new lines were completed the cover was repaired and the reservoir brought back into service.
